Location:
Mobile, AL

Date:
Summer 2008

PROJECT PROFILE

EFS Inspection of the Mobile River Delta Bridge

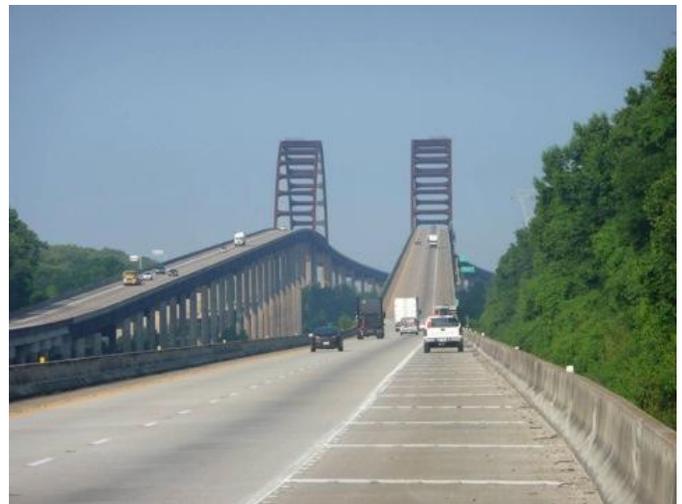
The EFS system was used to inspect a total of ten locations across the two bridges. Of these ten locations inspected, and under the traffic conditions present during inspection, seven of the ten locations were found to have actively growing cracks. Specifically, four of the five

visible cracks were found to be actively growing cracks that hadn't been previously repaired. At three of the five locations without visually detectable cracks, it was determined that growing cracks did, in fact, exist. Further, 66% of the locations that had been repaired had cracks that continued to grow despite the repair.
