**Location:**  
I-83 South Bridge  
Harrisburg, PA

**Date:**  
October 2009

# EFS Inspection of I-83 Harrisburg South Bridge

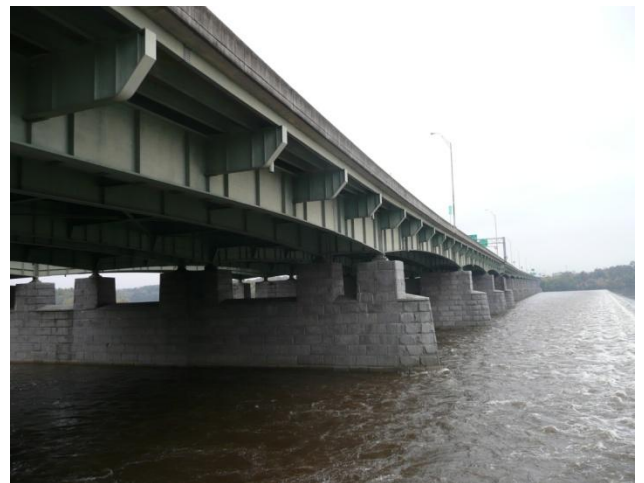
Biennial inspections revealed that the ramp girder terminations have developed multiple fatigue cracks. Drill stop holes were installed at the crack tips in July of 2008. The EFS system was used to inspect repair locations where drill stops had been used to arrest fatigue cracks. Also, four additional repaired locations were inspected.

Under the conditions inspected, the data indicate that thirteen of the twenty-three drill holes are not functioning as crack arrestors. Seven of the drill stop locations had plastic (permanent) deformation occurring or a small crack already initiated and propagating. Six of the locations had precursors to plastic (permanent) deformation, called microplasticity in Table 1, which may cause crack initiation in the future. Ten of the drill holes did not exhibit microplasticity or plasticity.
