EFS Inspection of the Sacramento River Viaduct

Location:
Sacramento, CA

Client Contacts:
CALTRANS

Date:
December 2007

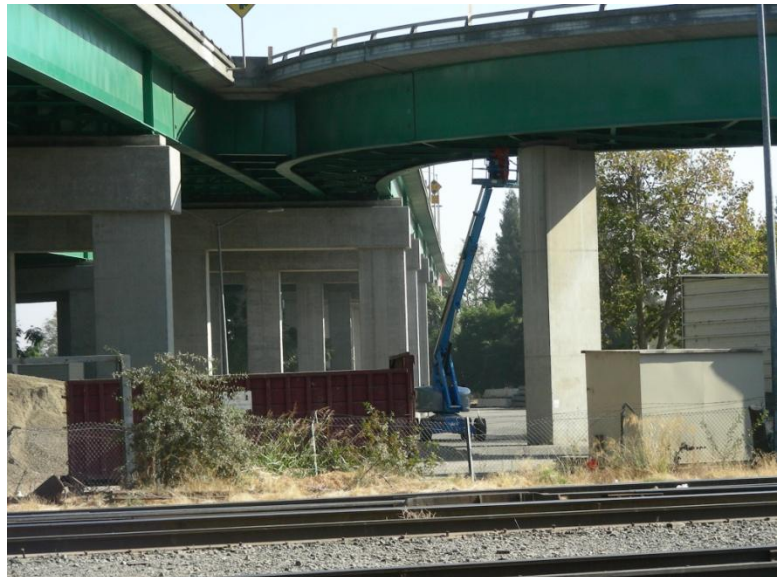
Four of those locations had been retrofitted, six locations exhibited visible cracks, and one location had no signs of cracking. The EFS system was installed on December

Four of the six visibly detectable cracks showed that the crack was actively growing. Three of the four retrofitted locations showed no signs of plasticity in the immediate area of the retrofit. One retrofit exhibited plasticity, which indicates that fatigue crack initiation is likely in the future and should be kept under observation.

The location with no visibly detectable crack showed no signs of fatigue cracking or plasticity.
