Location:
Steven's Point, WI

Date:
2008

EFS Inspection of the Steven's Point Rail Bridge

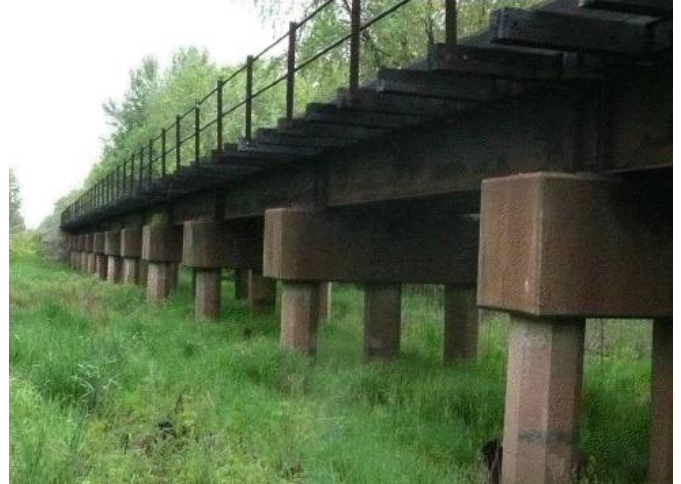
The Canadian National Railway (CN) used Metal Fatigue Solution's Electrochemical Fatigue Sensor (EFS) System to determine the presence and activity of fatigue cracking on the Steven's Point Rail Bridge. A total of seventeen (17) locations on nine (9) connection details were investigated. All seventeen (17) locations were of the same critical detail.

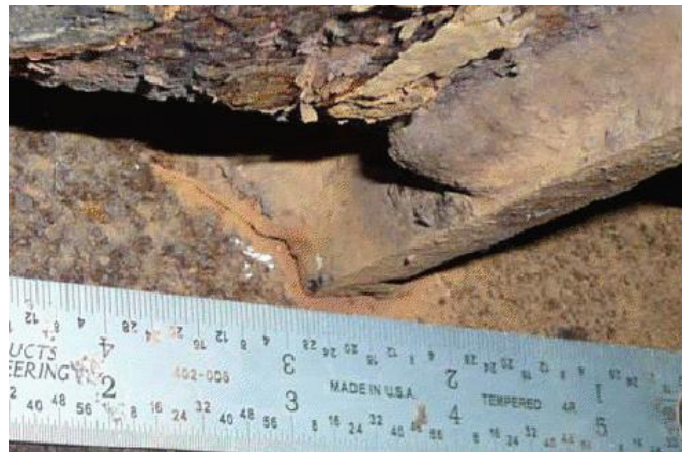
A visual inspection revealed that cracks had formed around the toe of the welds at the connection detail and had either propagated into the base metal, or continued along the toe of the weld itself. The EFS data analysis was used to determine whether the visible fatigue cracks were actively growing under ambient traffic flow and if there were any imminent cracks that were likely to develop at similar detail locations.

Using the EFS system, it was determined that nine locations had cracks that were actively growing, two locations showed the early signs to crack growth and six (6) locations showed no signs of cracking or imminent cracking.
