Location:
Albany, NY

Date:
Summer 2008

EFS Inspection of the Patroon Island Bridge

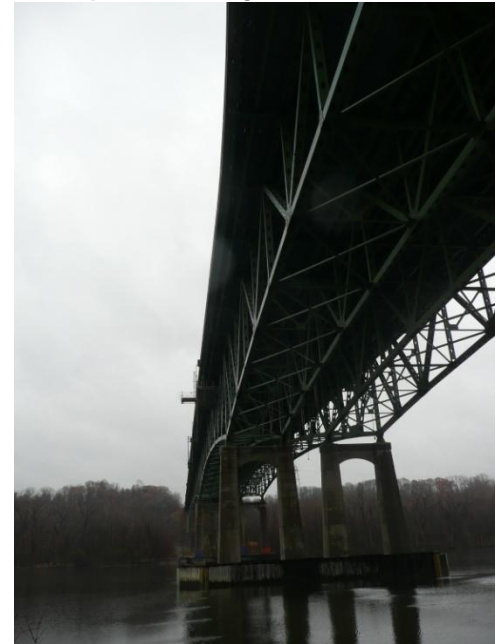
New York State Department of Transportation (NYSDOT) used Metal Fatigue Solution's Electrochemical Fatigue Sensor (EFS) System to inspect the Patroon Island Bridge (BIN 1092839) over the Hudson River in Albany, NY. Two inspections were completed on the Patroon Island Bridge, one in November of 2007 and one June of 2008. Eight locations on four fatigue-retrofitted details were inspected using ESI's patented Electrochemical Fatigue Sensor (EFS) system. The four retrofits were designed and installed to remediate fatigue-cracking problems at floor beam to gusset plate connections. The retrofit design included the removal of a large teardrop-shaped section of material in order to remove the cracked area and distribute the stress field at the floor beam to gusset plate connection.

During the inspection, custom sensors were installed around the unique teardrop shape. The sensors were placed around retrofits at locations where NYSDOT anticipated higher strains. The EFS inspection data was used to determine if microplasticity was occurring. Higher levels of microplasticity indicate the potential for future crack initiation and growth.

A total of eight locations, two locations on each of the four retrofits, were tested with the EFS system. EFS data was collected during peak traffic flow with all lanes open. The EFS data and analysis were used to determine whether the completed retrofits were successful at preventing future fatigue initiation and growth. The data and analysis indicated that the retrofits were successful at reducing future risk for crack initiation and growth.

EFS verified efficacy of the retrofits installed at the connections.
