EFS Inspection – NSW, Australia

Various Locations Throughout
New South Wales, Australia

January 2009

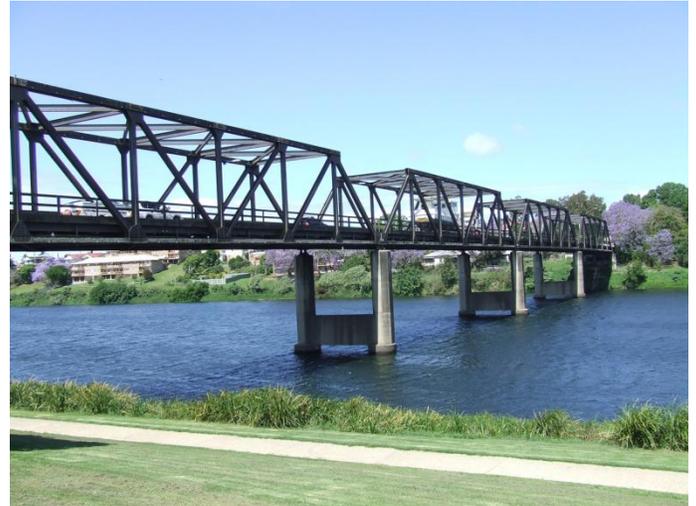
The EFS system was installed at areas where documented fatigue cracks were previously identified and at locations that had fatigue-sensitive details similar to those that had previously documented fatigue cracks, both repaired and not repaired. The EFS data and analysis software were used to determine whether existing cracks were actively growing, whether the retrofits were successful at arresting fatigue crack propagation, and whether similar fatigue susceptible details exhibited behavior indicative of current or future crack growth activity.
