## On-Call Inspection - PENNDOT

Various Locations Throughout Pennsylvania

Fall 2007

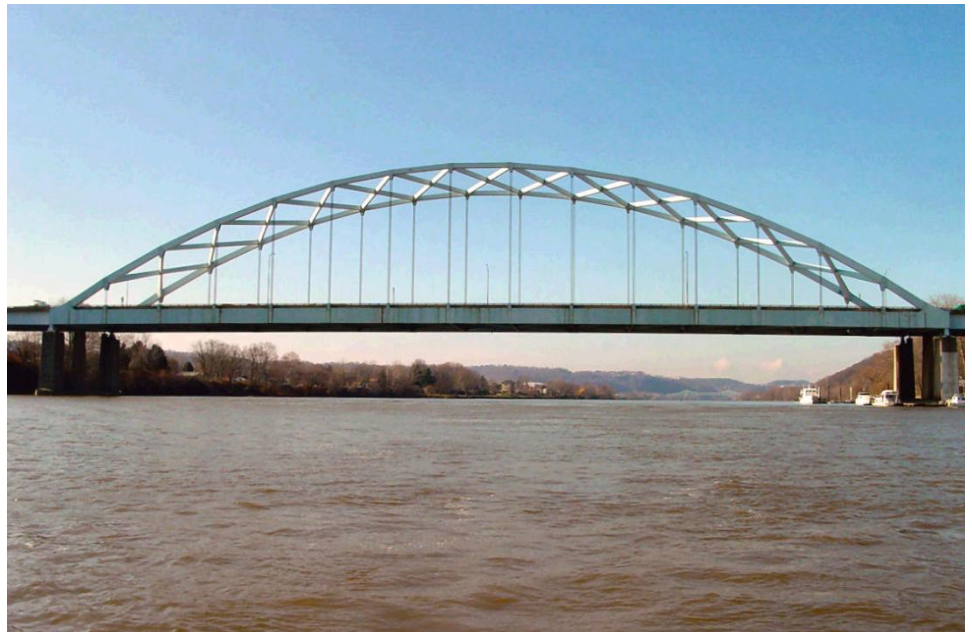
Tests at various locations indicated:

- 37% of locations tested were actively cracking.
- 11% of locations showed potential growth activity.
- Many retrofits were verified as effective.
- Deferment of repair funds was possible.
- Many locations were identified for early (less expensive) repairs.

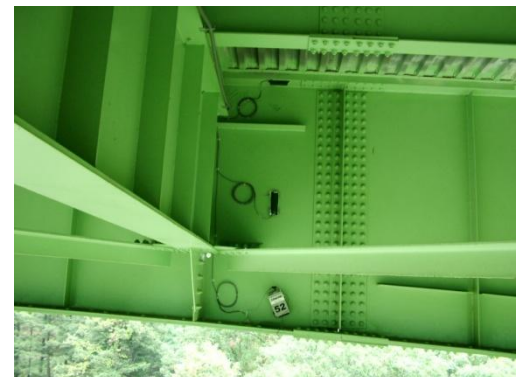
A total of 112 locations were inspected using the EFS system. A total of 41 growing cracks were identified. In some cases, these growing cracks were located where repairs had previously been made. Another 12 locations exhibited microplasticity that is indicative of the potential for future crack growth.

The remaining 59 locations did not have actively growing cracks.
